EARTHQUAKE INDUCED FISSURING IN BANKS
PENINSULA LOESSIAL SOILS: A GEOTECHNICAL
INVESTIGATION OF THE RAMAHANA ROAD FISSURE
TRACE

A thesis submitted in partial fulfilment
of the requirements for the Degree of
Master of Science in Engineering Geology
In the Department of Geological Sciences
University of Canterbury

Christopher Stuart White

2016

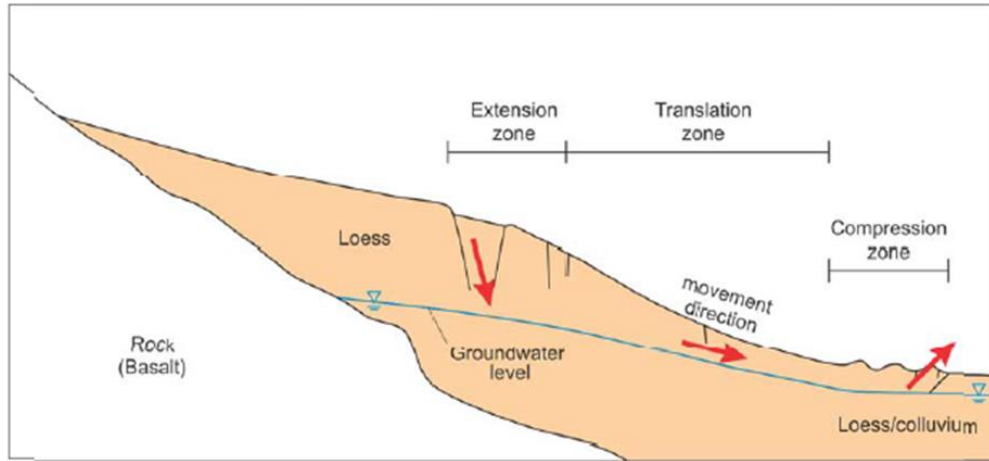
The most detailed studies to date on the fissure traces can be found in the GNS stage 1 report compiled by Massey et al. (2013) and the unpublished thesis by Stephen-Brownie (2012). Loess slumping, which is a rotational slide mass failure following the classification of Cruden & Varnes (1996), is deemed to be the most likely mode of failure in the work of Massey et al. (2013), and their loess slump hypothesis has since been widely accepted by various parties, including the Christchurch City Council (CCC) and many engineering consultancies. Figure 1.2 is the loess toe slump model from the GNS stage 1 report. Within the stage 1 report, however, it is recognised that the mechanisms of movement are poorly understood, and considerable geotechnical investigations are needed to gain greater understanding of the fissure trace movement. At this stage it would seem presumptuous to nominate the fissure traces as slide or slump landslide movement types.

Figure 1.2: The loess toe slump model. From Massey et al. (2013).

Slide movement is currently the generally accepted form of movement for the Ramahana Road fissure trace, largely due to the work of Massey et al. (2013) who classified the type of movement as a toe-slump in loess. Figure 1.2 is a diagram of how the loess toe-slump movement was visualised by the authors. A slump is a synonym for a rotational slide, and this implies that the loessial soil moved as a mass in an outwards and downwards direction, on a concave-upward basal shear surface (Cruden and Varnes, 1996).

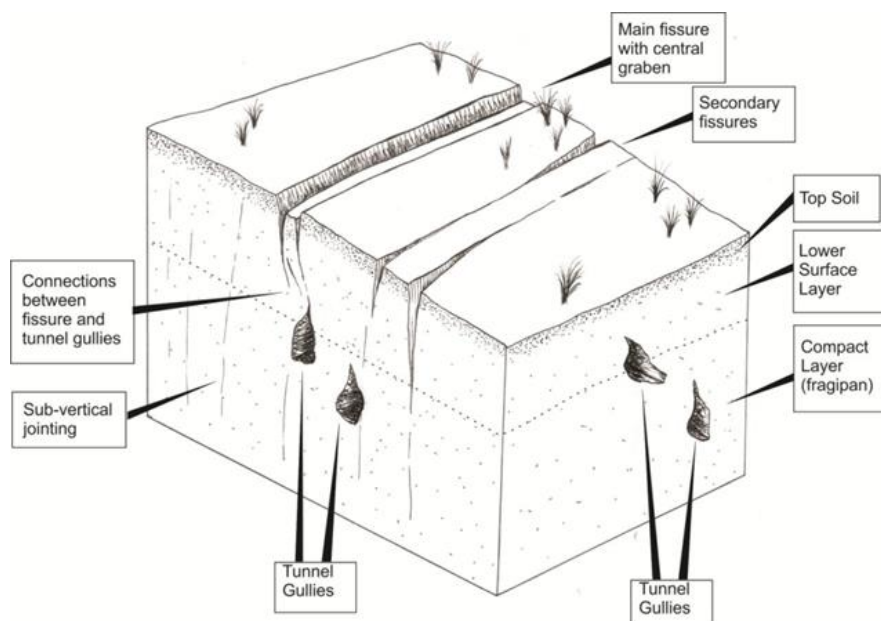
Stephen-Brownie (2012) offered an alternative hypothesis to the fissure trace mode of movement, in which a combination of bedrock fracturing of the up-thrusted Port Hills volcanics propagated stress into the overlying loessial deposits, while the ‘trampoline effect’ (where strong downward acceleration during an earthquake causes dilatational strains that make the near surface material reach their bulk tensile strain, causing the soil and rocks to lose their cohesion (Aoi et al. 2008)) temporarily removed lateral strength of the slope, causing an imbalance of stresses, and resulting in lateral spreading similar to the fissures that formed parallel to river banks on the flatlands. It was thought that the fissures formed along internal sub-vertical fractures that are inherent in the loess deposits of the Port Hills, and therefore could be defined as a quasi-toppling movement following the classification of Cruden & Varnes (1996). Figure 1.3 provides for a model of the quasi-toppling movement.

Figure 1.3: The quasi-toppling model. From Stephen-Brownie (2012).

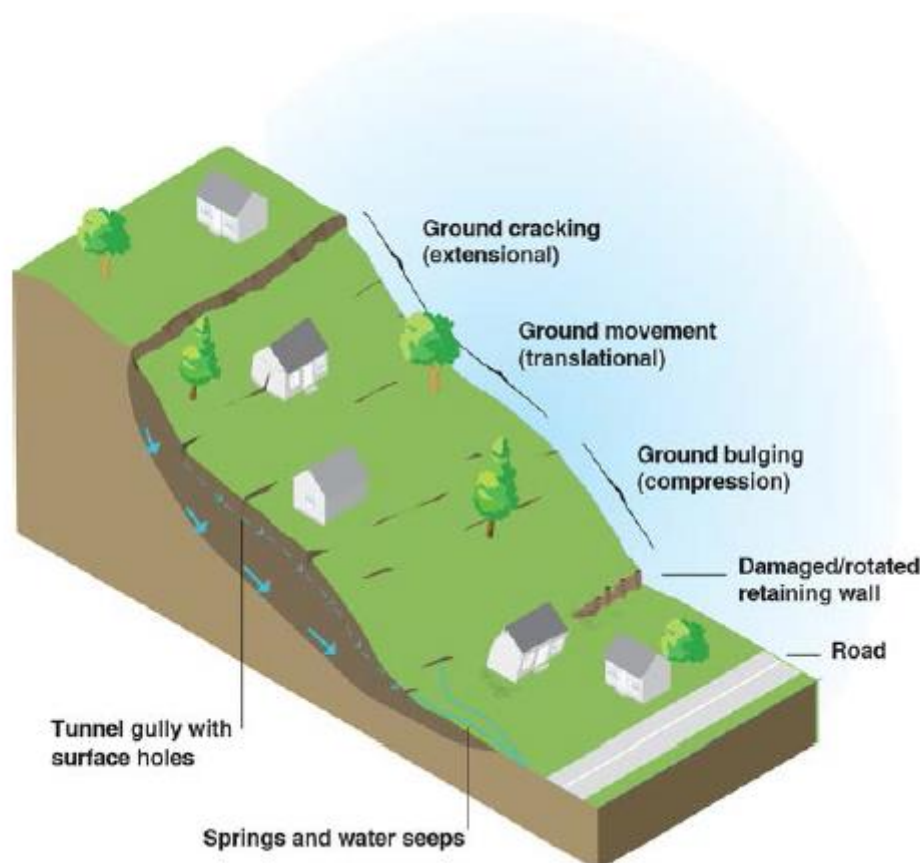
Figure 1.5 is a schematic model from the ‘Build it Right Canterbury’ report by the Ministry of Business Innovation and Employment, which depicts the toe slump model. If this model is accepted as the mode of movement for the fissure traces, then it will have to be assumed that any construction built within the zone of movement will be adding loading to the slide surface and all geotechnical constraints that accompany this assumption will need to be considered. In contrast there are no loading implications for construction under the quasi-toppling model assumption.

Figure 1.5: A schematic model of the toe slump hypothesis sourced from ‘Build it Right Canterbury’ report, after the Ministry of Business Innovation and Employment (2013).

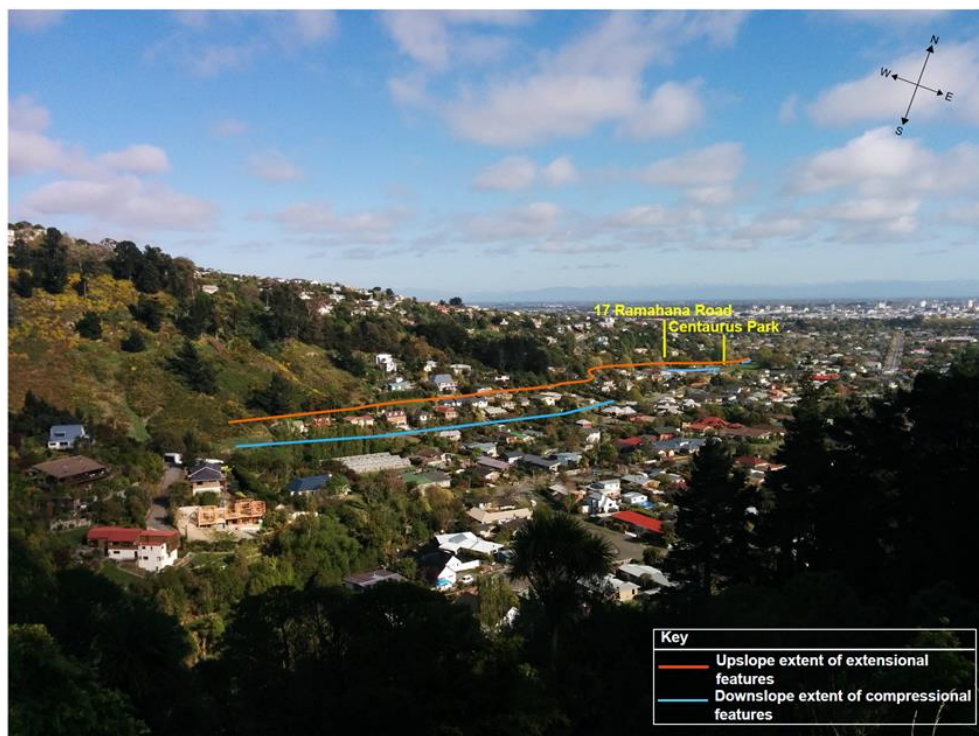
Figure 1.8: Photo of the Ramahana Road fissure trace area taken from the top of Rapaki Road facing North West. The area of fissuring had been overlaid to show the toe slope location and gentle slope where they occur.

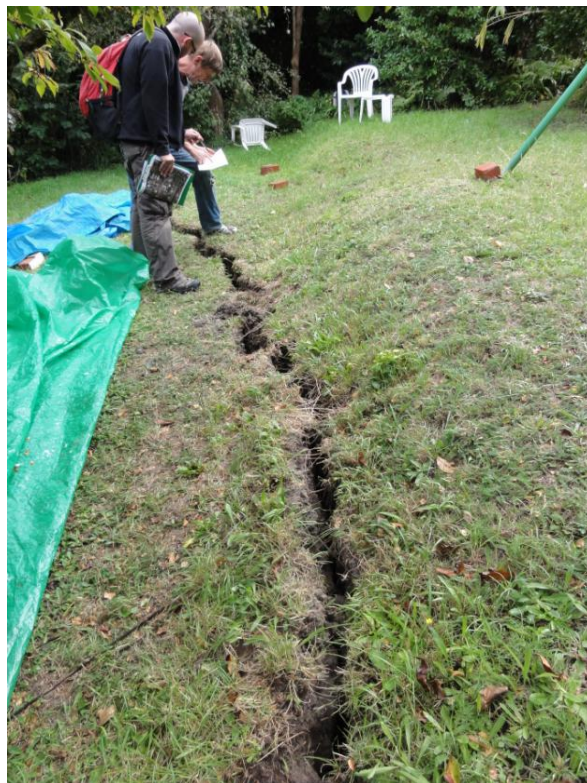
Figure 1.10: A fissure trace on the Vernon Terrace side of the Hillsborough valley showing a roughly linear orientation with mostly horizontal displacement in the downslope direction. Photo from Dellow et al. (2011).

The maximum accumulative displacements recorded by Massey et al. (2013) were 0.6m horizontal and vertical for the Ramahana Road section, and 0.8m horizontal and 0.4m vertical for the Albert Terrace section. The horizontal displacement is predominant, and this allows an open view into the trace; whereas the vertical displacement is not always evident.

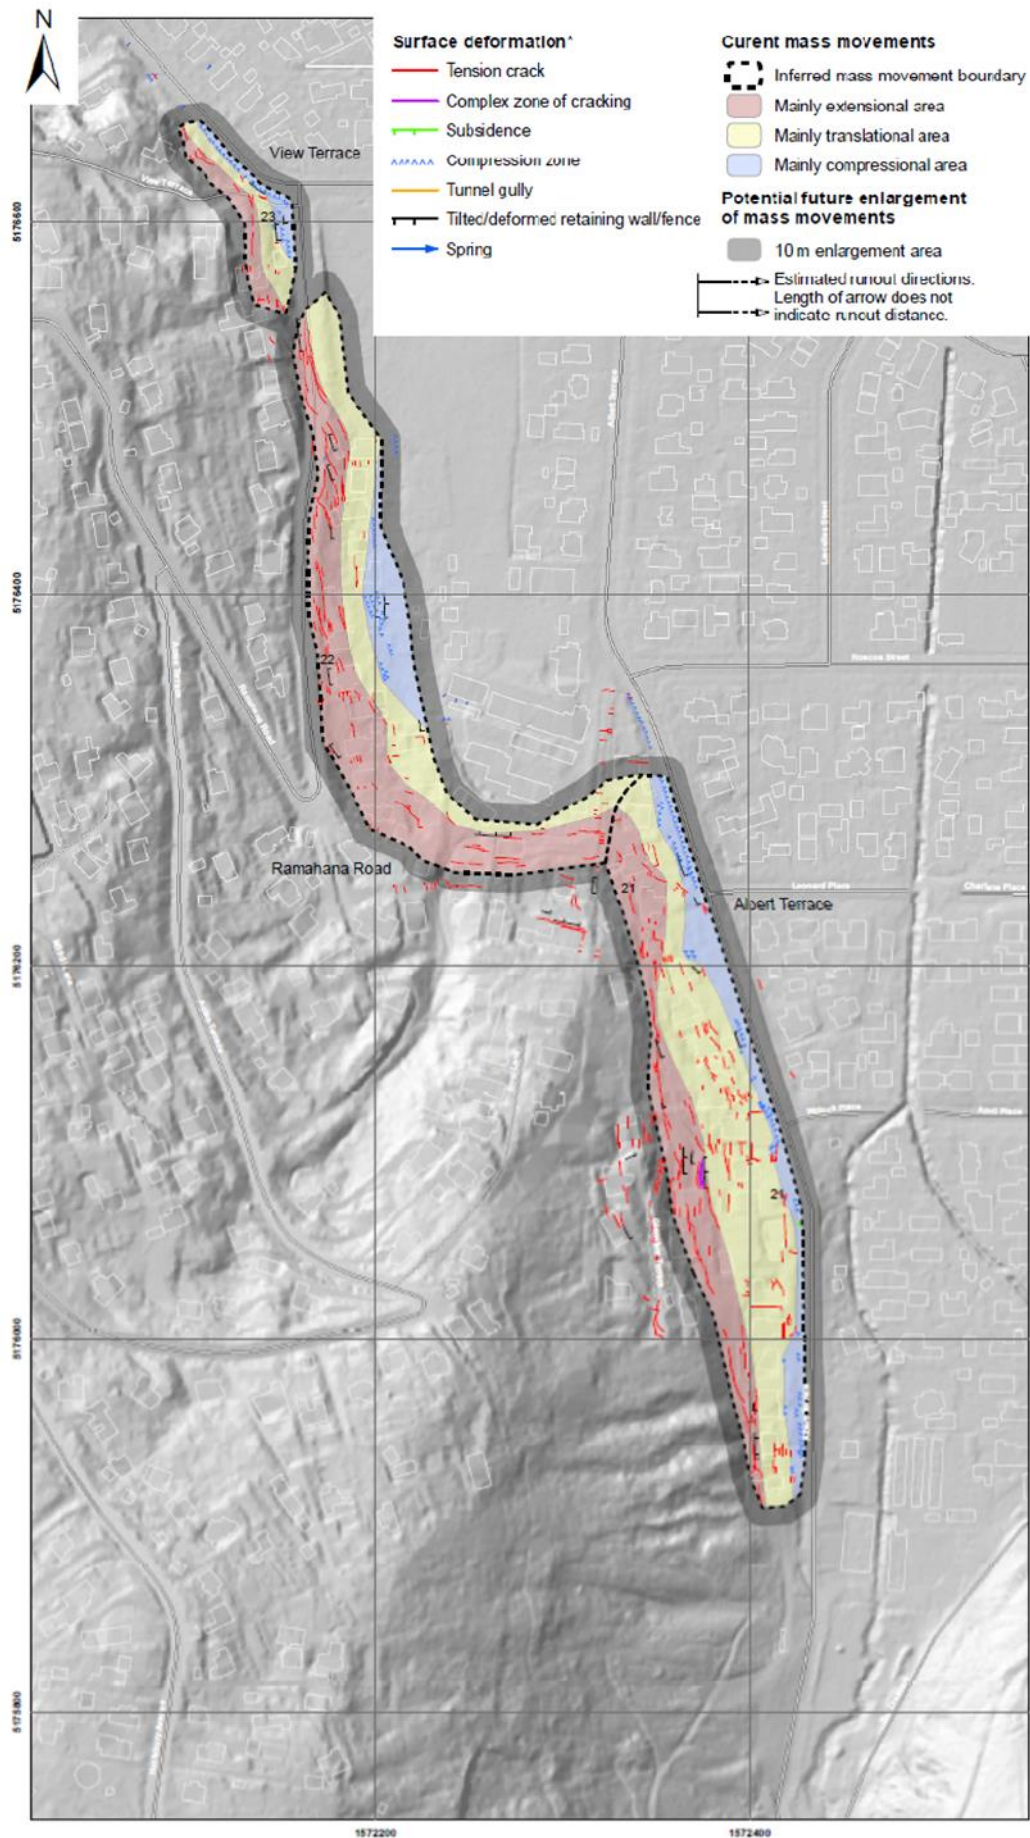
Between the compressional features and the extensional features there is a zone with no obvious deformation, which has been interpreted as a translational zone by Massey et al. (2013). Figure 1.12 illustrates the extensional, compressional, and translational zones as interpreted by Massey et al. (2013). Houses that were located within the translational zone during the 22nd of February 2011 Christchurch Earthquake are without significant damage to foundations.

Figure 1.12: The Ramahana Road Fissure Trace, modified after Massey et al (2013).

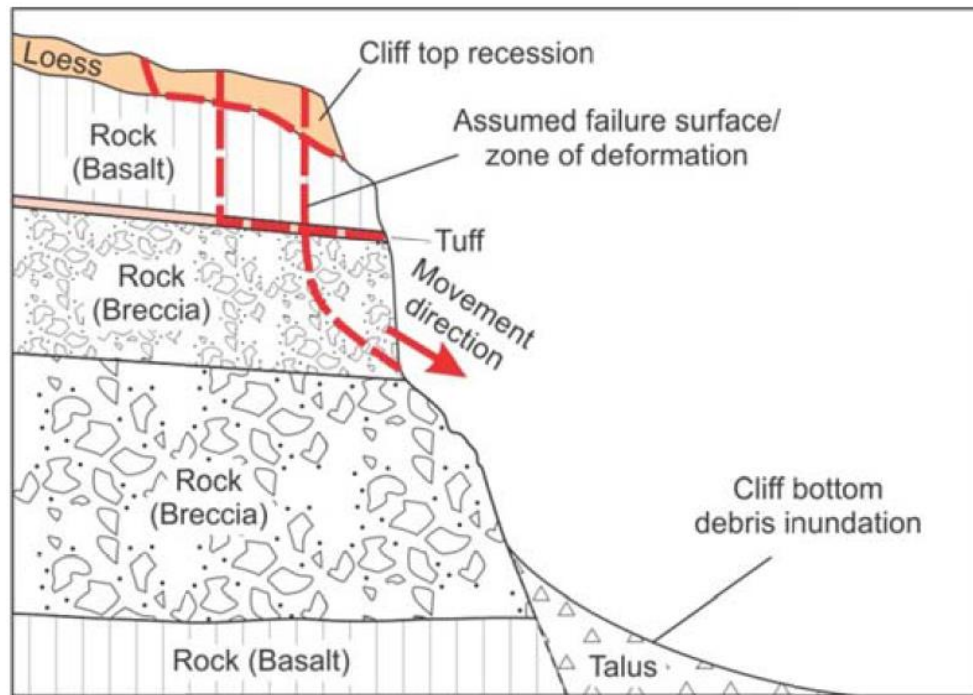
Figure 2.11: Rock and debris falls in the Port Hills during the Christchurch Earthquake. From Massey et al. (2012).

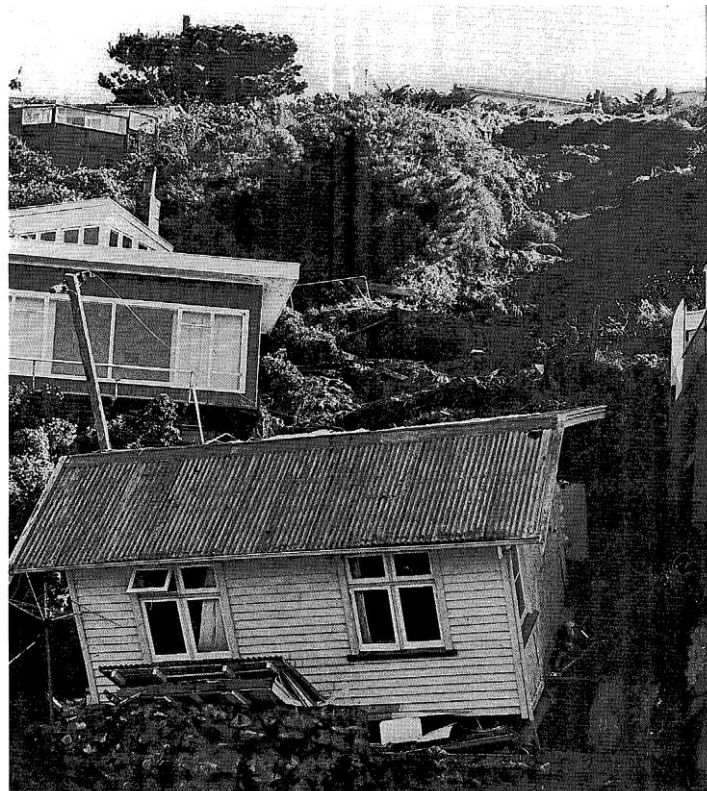
Figure 2.15: A slide-avalanche-flow in loess-colluvium at Taylors Mistake in 1975. Photo from Brown & Weeber (1995).

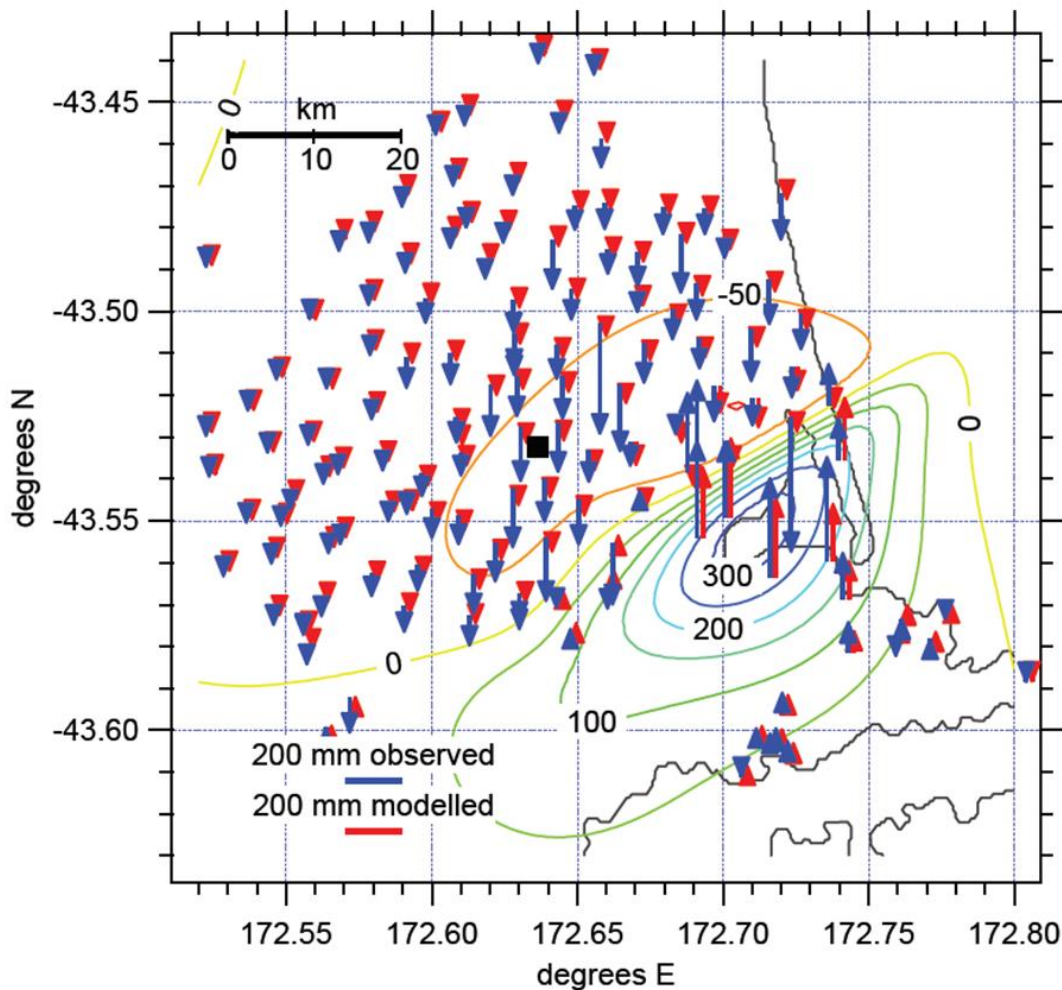
Figure 2.17: Observed and modelled uplift and subsidence around Christchurch following the Christchurch earthquake. Blue is for observed and red is for modelled. Central Christchurch is depicted as the black square in the centre of the model and the outline of the east coast is the black lines on the right side. The contours are predicted displacements with 50 mm contours. From Beavan et al. (2011).

It is also interesting to note that the fissure traces are all to the east of where the Port Hills Fault extends beneath the Port Hills, and to the west of this the occurrence of the fissure traces ceases. This suggests that a factor involved in the generation of the fissure traces could have been uplift of the Port Hills in relation to subsidence of the Christchurch city flat lands. The fissure traces roughly occur on the boundary of this difference in movement (see also Figure 2.17).

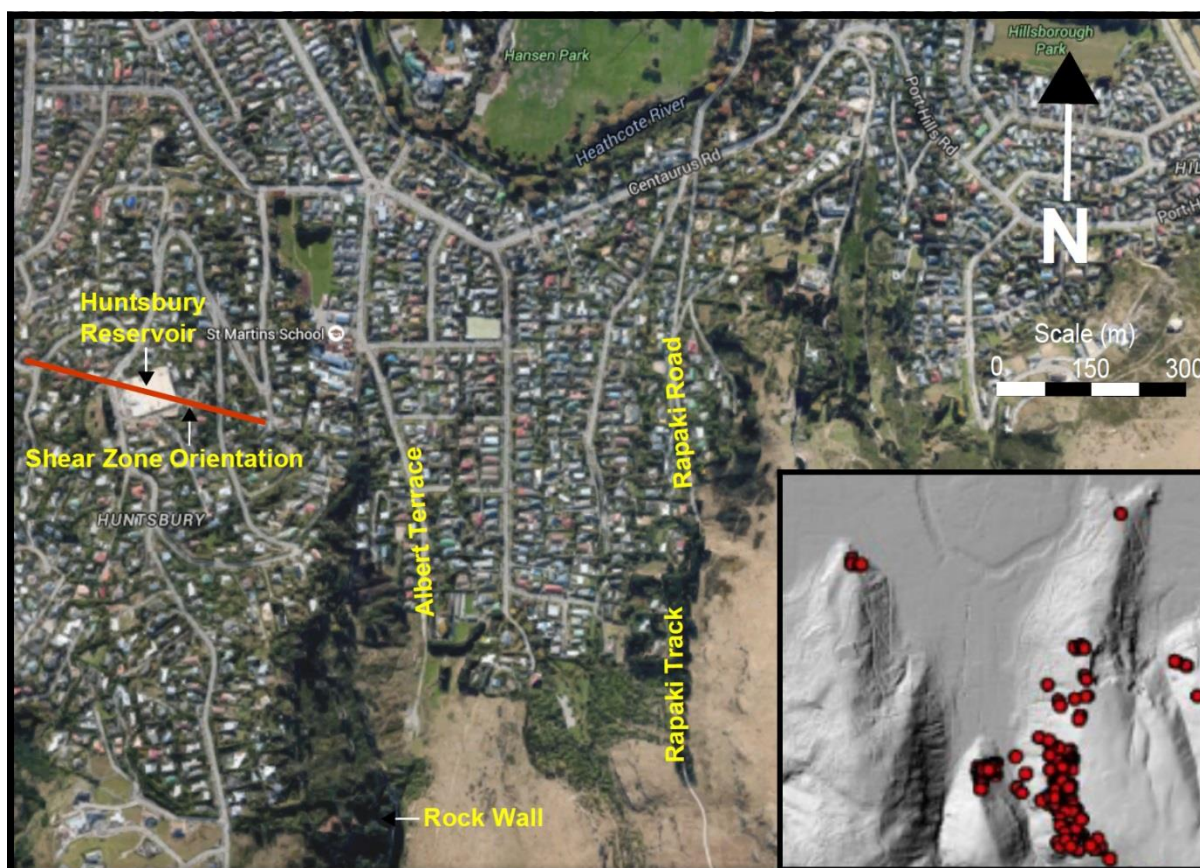
The Huntsbury reservoir, which is situated on the ridgeline above Albert Terrace, was severely damaged by the Christchurch Earthquake. Beca Infrastructure Ltd (2011) studied the damage and found that a series of fractures in the floor of the reservoir had caused the stored 36,000,000 L of water to drain into the Lyttelton Volcanic Group rock below. These fractures had an average strike of 290-315° and a dip of 65-85° ± 10° SW, which does not correspond with the Port Hills Fault. Slickenside surfaces and soft clay gouge in the inlet/outlet pipe led to the conclusion that this was an old feature that had become reactivated by the Christchurch Earthquake. Figure 2.19 shows the Huntsbury Reservoir and the orientation of the shear zone.

Figure 2.19: The Huntsbury Reservoir and shear zone orientation. Albert Terrace and Rapaki Road are shown for locations of rockfall. The insert on the right is a section of a rockfall map sourced in Vick (2015) showing the locations of rockfall in the Hillsborough Valley.

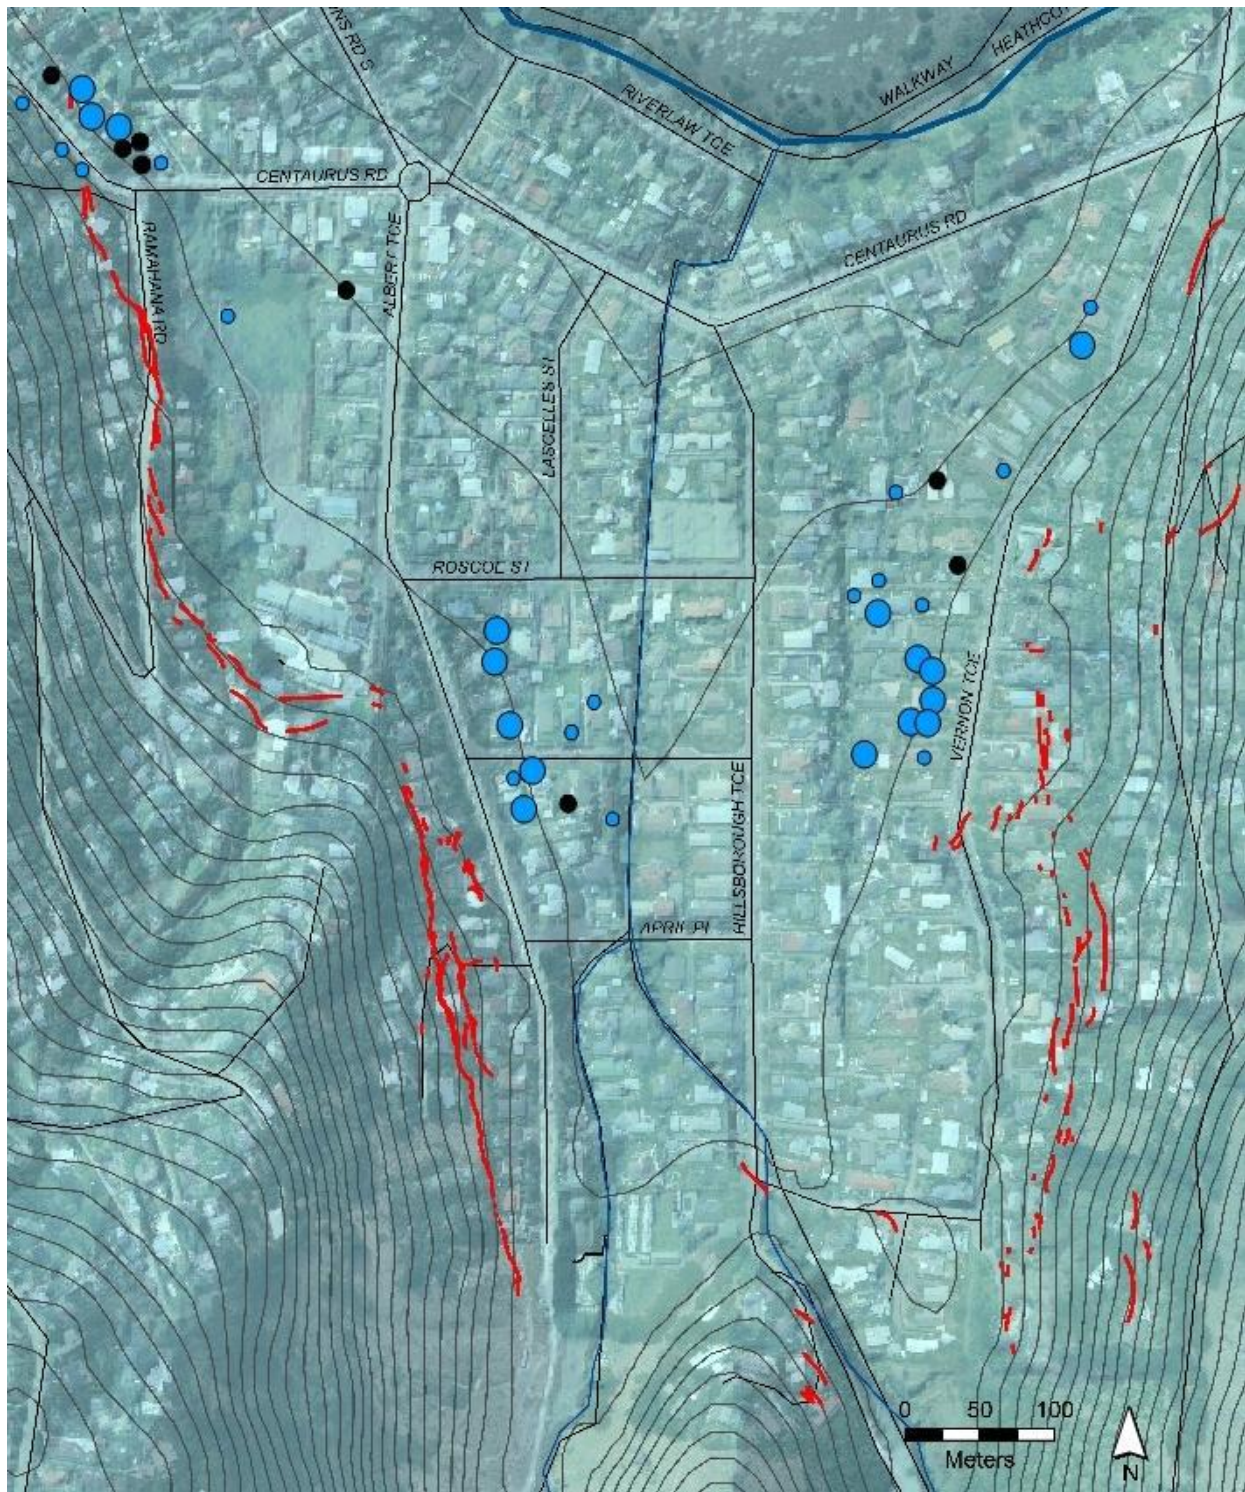
No surface springs were evident near Ramahana Road prior to the Christchurch Earthquake, but it is one of the peculiar features of the fissure traces that new springs began seeping water to the ground surface at the base of the slopes within a few days of the Christchurch Earthquake, and in some places even following the Darfield Earthquake. Stephen-Brownie (2013) explains that the Hillsborough Valley was affected by at least 24 new springs following the Christchurch Earthquake, and that these were still flowing in August 2013. It can now be confirmed that the springs were still flowing in December 2015, although the flow rates have dropped in some springs. Figure 2.20 indicates the locations of new springs following the Christchurch Earthquake.

The springs are generally located to the downslope side of the compressional zones of the fissure traces, but they can also be found within the fissure traces themselves (e.g. at 211 Centaurus Road). Figure 2.20 shows the location of the fissure traces. Flat ground affected by spring flow at the base of Hillsborough Valley, such as in household gardens and in Centaurus Park, has essentially been turned back into their pre-suburban state of swamp land.

Figure 2.20: Location of new springs in the Hillsborough Valley. From Stephen-Brownie (2012).

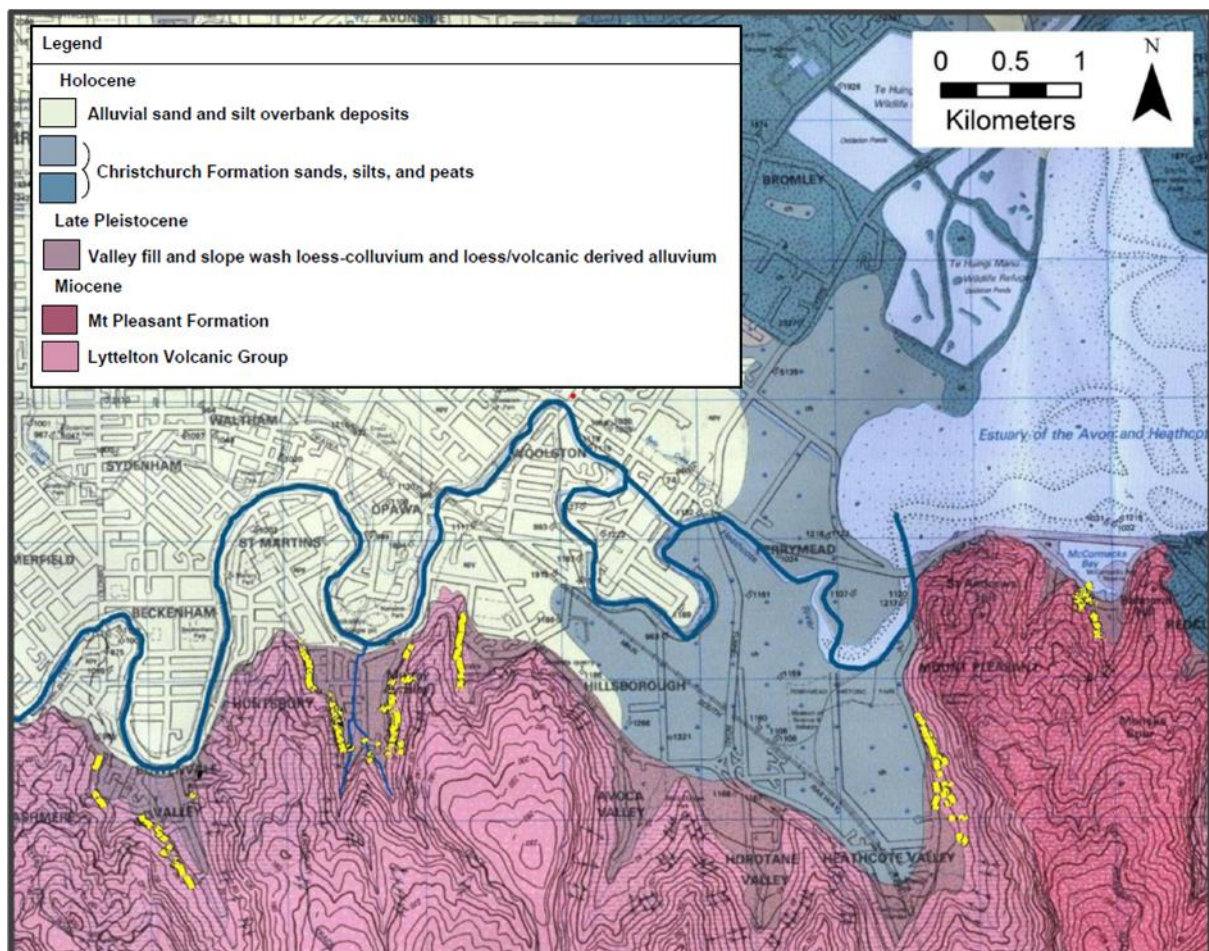
Figure 3.2: Part of the 1:25,000 geological map of the Christchurch urban area produced by Brown & Weeber (1992), with fissure traces, as mapped by Stephen-Brownie (2012), overlaid.

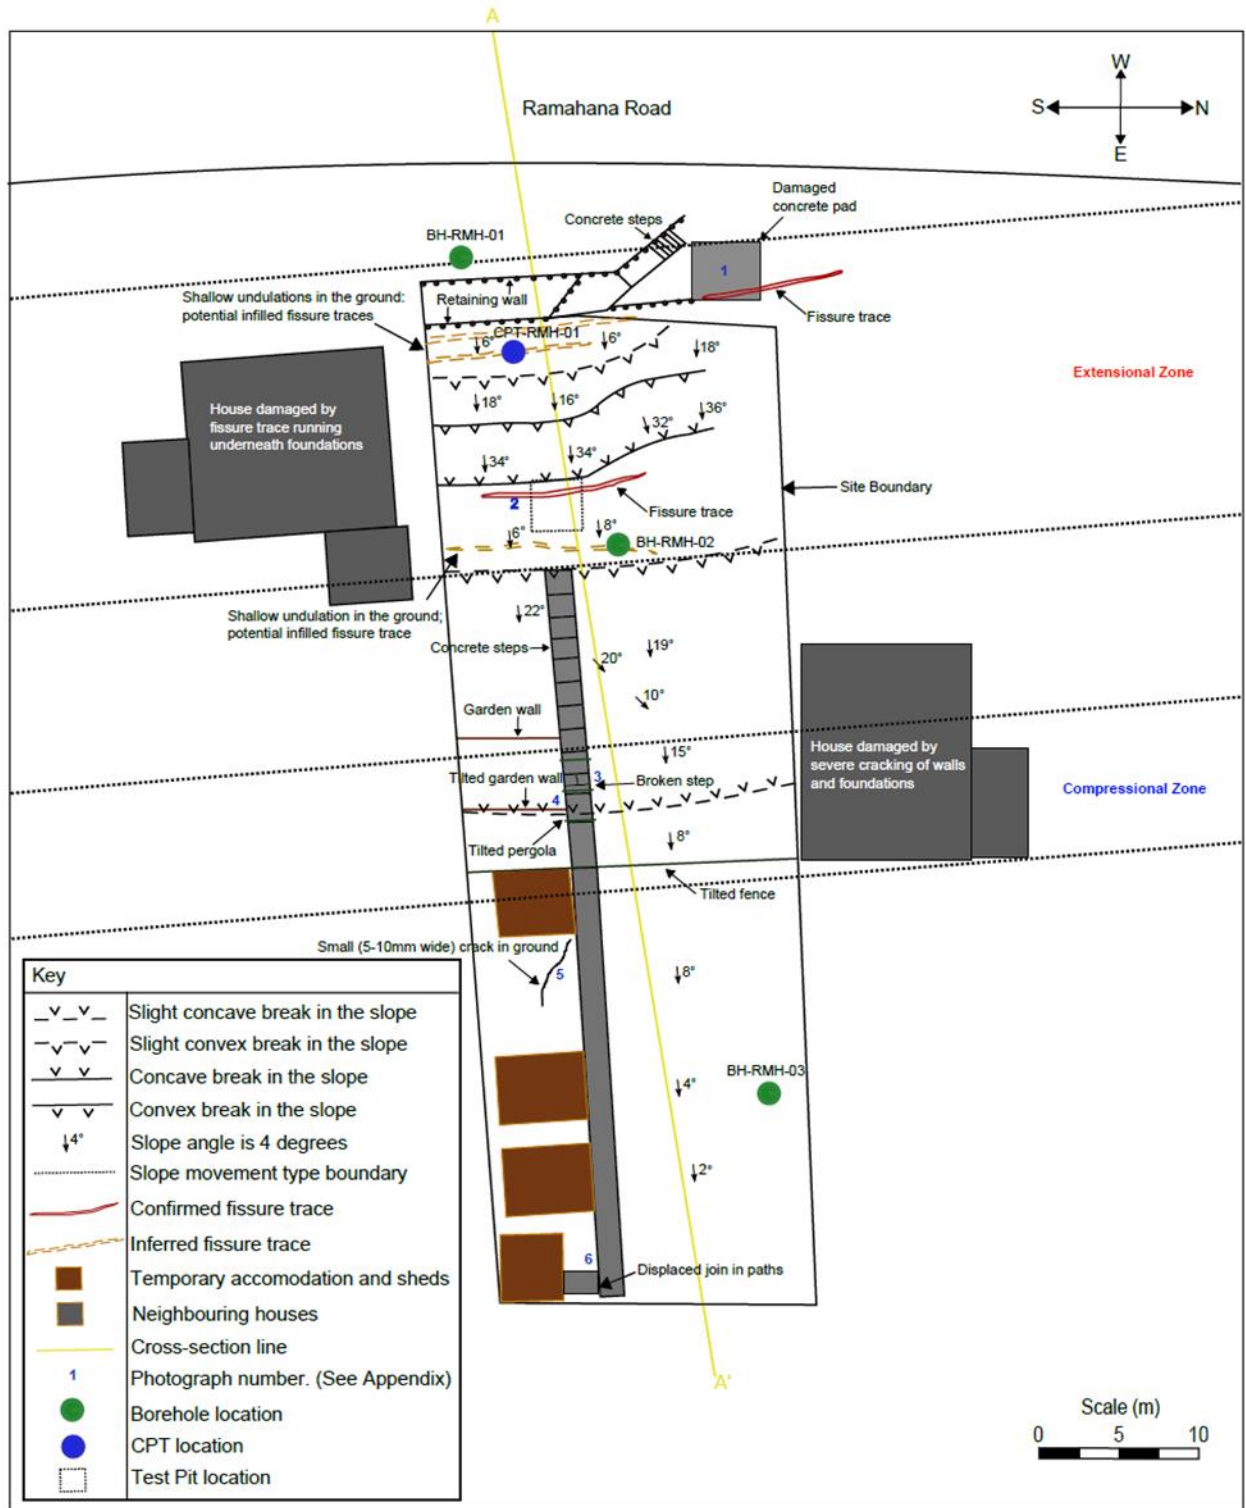
The site has an undulating slope, it generally has a relatively gentle gradient of $<20^\circ$, but it varies from 2° at the valley floor to 36° at localized steeper gradients near the top of the slope. There is mixture of old structures that were present before the earthquake and ones that have been built since. The new structures include temporary accommodation at the base of the slope and the wooden retaining wall at the top of the site. The old structures include a concrete pad that was damaged by a fissure opening beneath it; a concrete path with a cracked step at the base of the slope, and a displaced side path at the valley floor; two sheds at either side of the temporary accommodation; and a tilted fence, pergola, and garden retaining wall. The old structures on the site help to identify the boundaries of the extensional and compressional zone. The damage to the neighbouring houses corresponds with these zones of deformation.

The fissure traces are present at the top of the site. Only two traces were clearly visible and easily identified as fissure traces, whilst three potential traces were observed as shallow undulations in the ground. The demolition of the old house, building of the new retaining wall, and clearance of vegetation is likely to have in-filled these features, and in-filling was evident in the two more obvious fissure traces. A small crack (5-10mm wide) that ran approximately NWW-SEE was also identified downslope from the compressional zone.

Figure 3.5: 17 Engineering geological map of 17 Ramahana Road. Refer to Figure 5.4 for cross-section. Appendix 2.1 presents mapping photos, and Appendix 2.8 shows the borehole logs from Tonkin & Taylor Ltd.

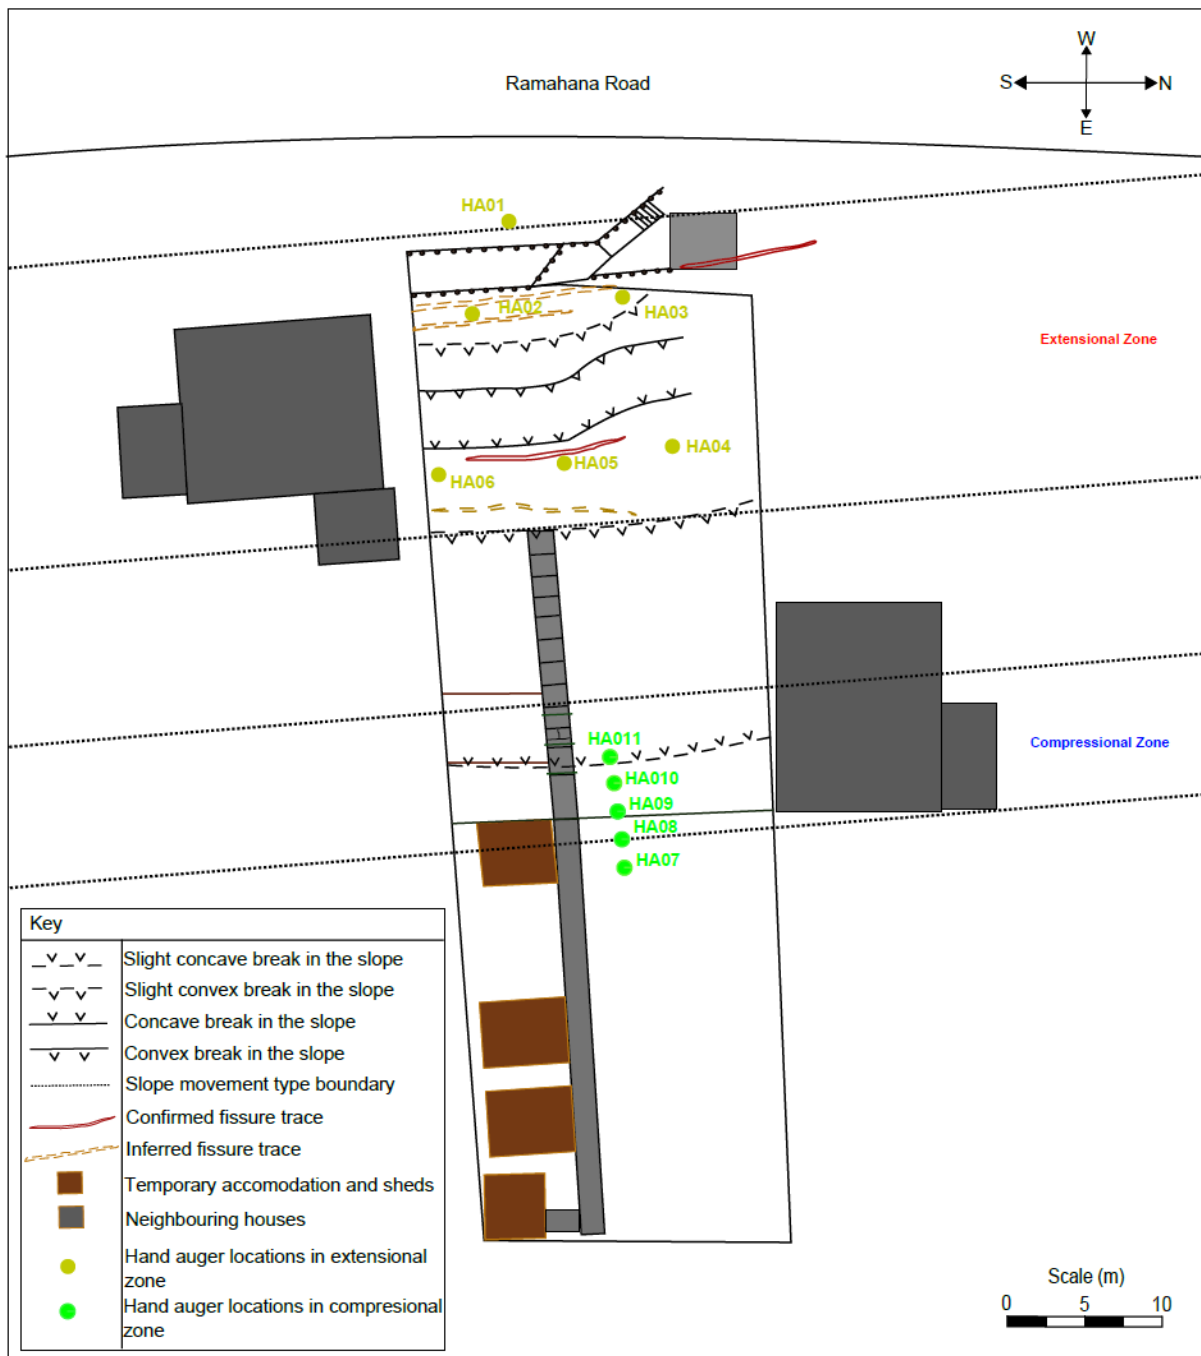
Figure 3.10: Hand auger and DCP locations at 17 Ramahana Road as part of geotechnical appraisal and testing the compressional zone at the site.

The soil logged from the six hand augers in the extensional zone generally had an engineering geological description of SILT with some clay and minor sand, trace gravel; yellowish brown. Firm to stiff, moist, low plasticity; sand, fine; gravel, fine, basalt. The moisture content generally increased with depth, but there were pockets of higher moisture contents within a generally low moisture content soil mass, and a particular section of high saturation near the ground surface in HA3. The DCPs identified that an ultimate bearing

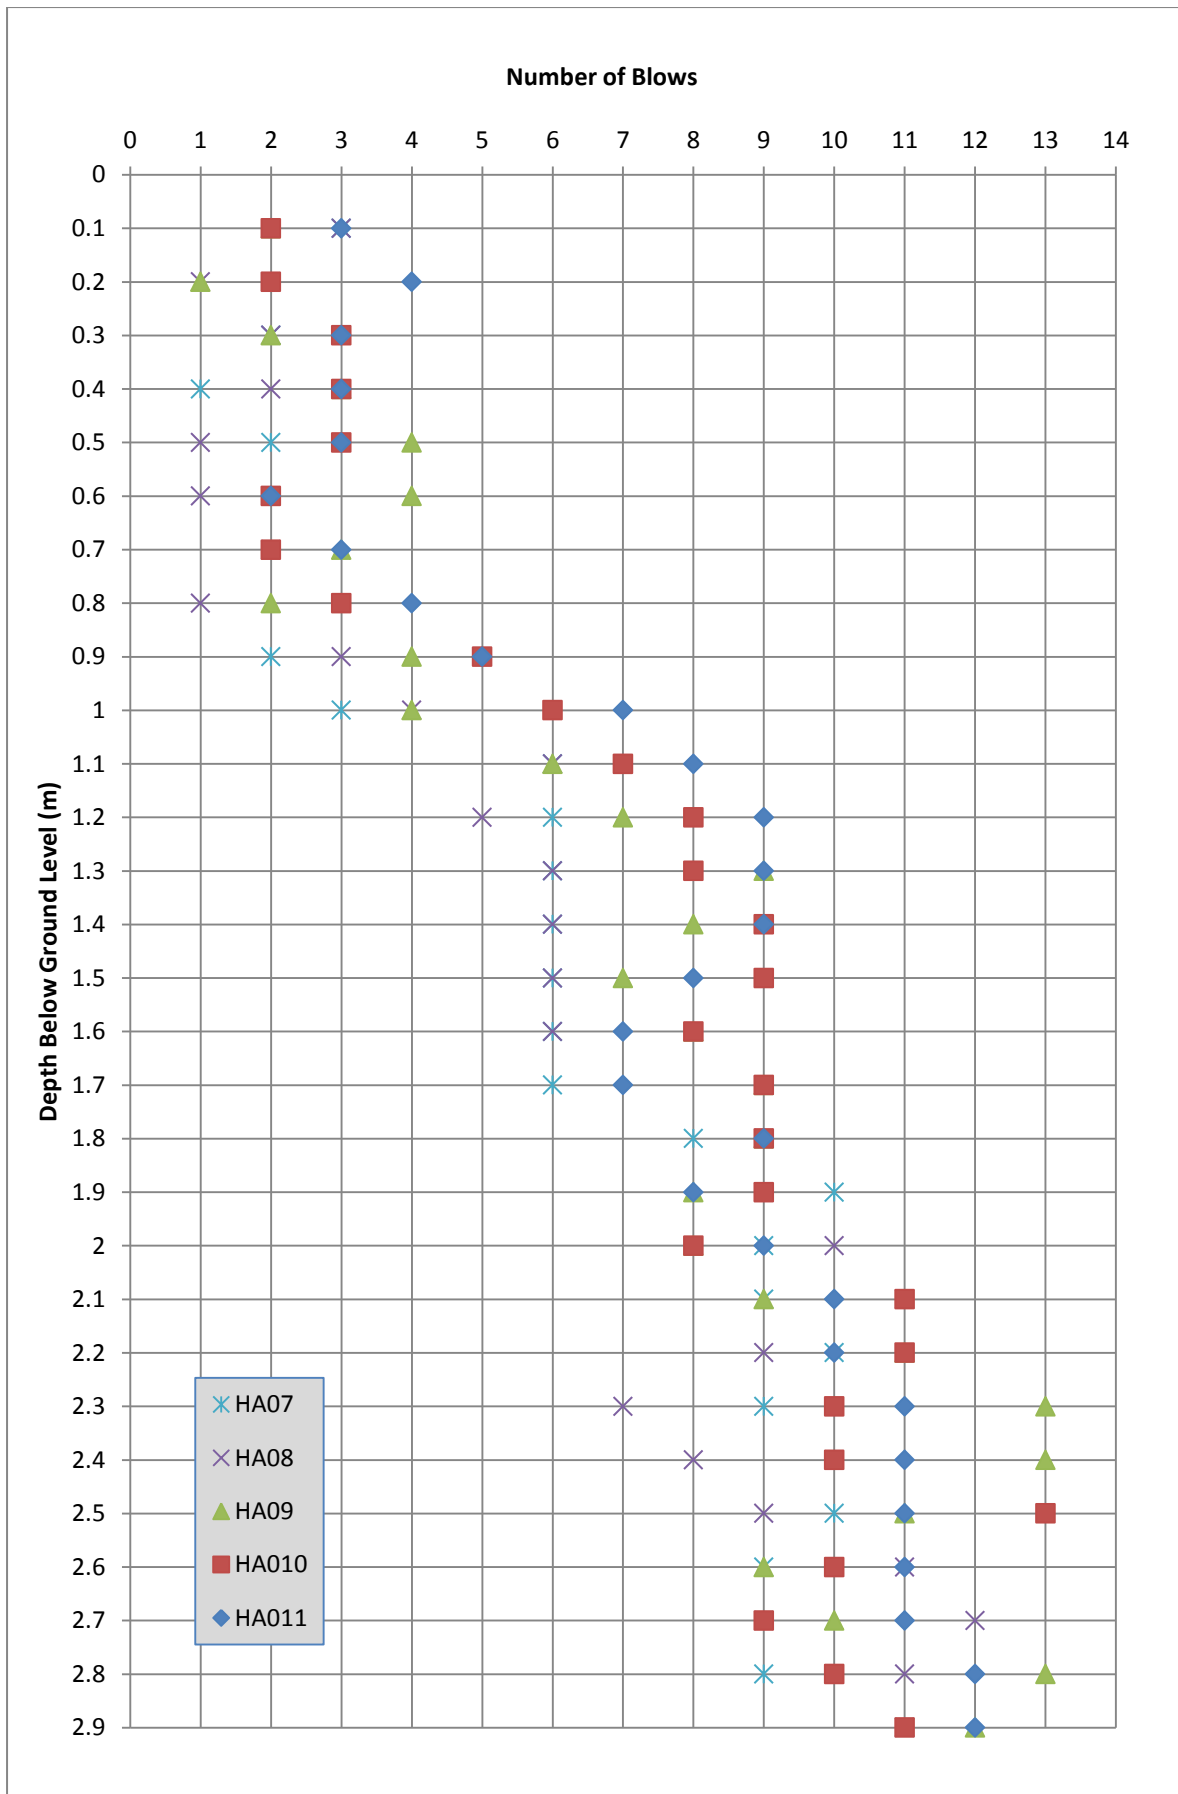
Figure 3.11 is a comparison of the DCP results for HA07-HA011 located in the compressional zone. HA09 is located closest to where the most compression is thought to have occurred. It was hypothesized that this soil would have more resistance to penetration due to its compressed, and therefore, denser state than the surrounding soil. What actually was recorded was gradual increase in number of blows/100mm depth in all of the DCP's, but there was generally less resistance in the downslope DCP tests than in the upslope ones. This could be more due to the moisture content being higher at the base of the slope than further up the slope than due to any changes in density in the soil, so density tests of *in-situ* samples were also conducted. The density tests are presented in Chapter 4.

Figure 3.11: Comparison of the DCP results for HA07-HA011 in the compressional zone at 17 Ramahana Road.

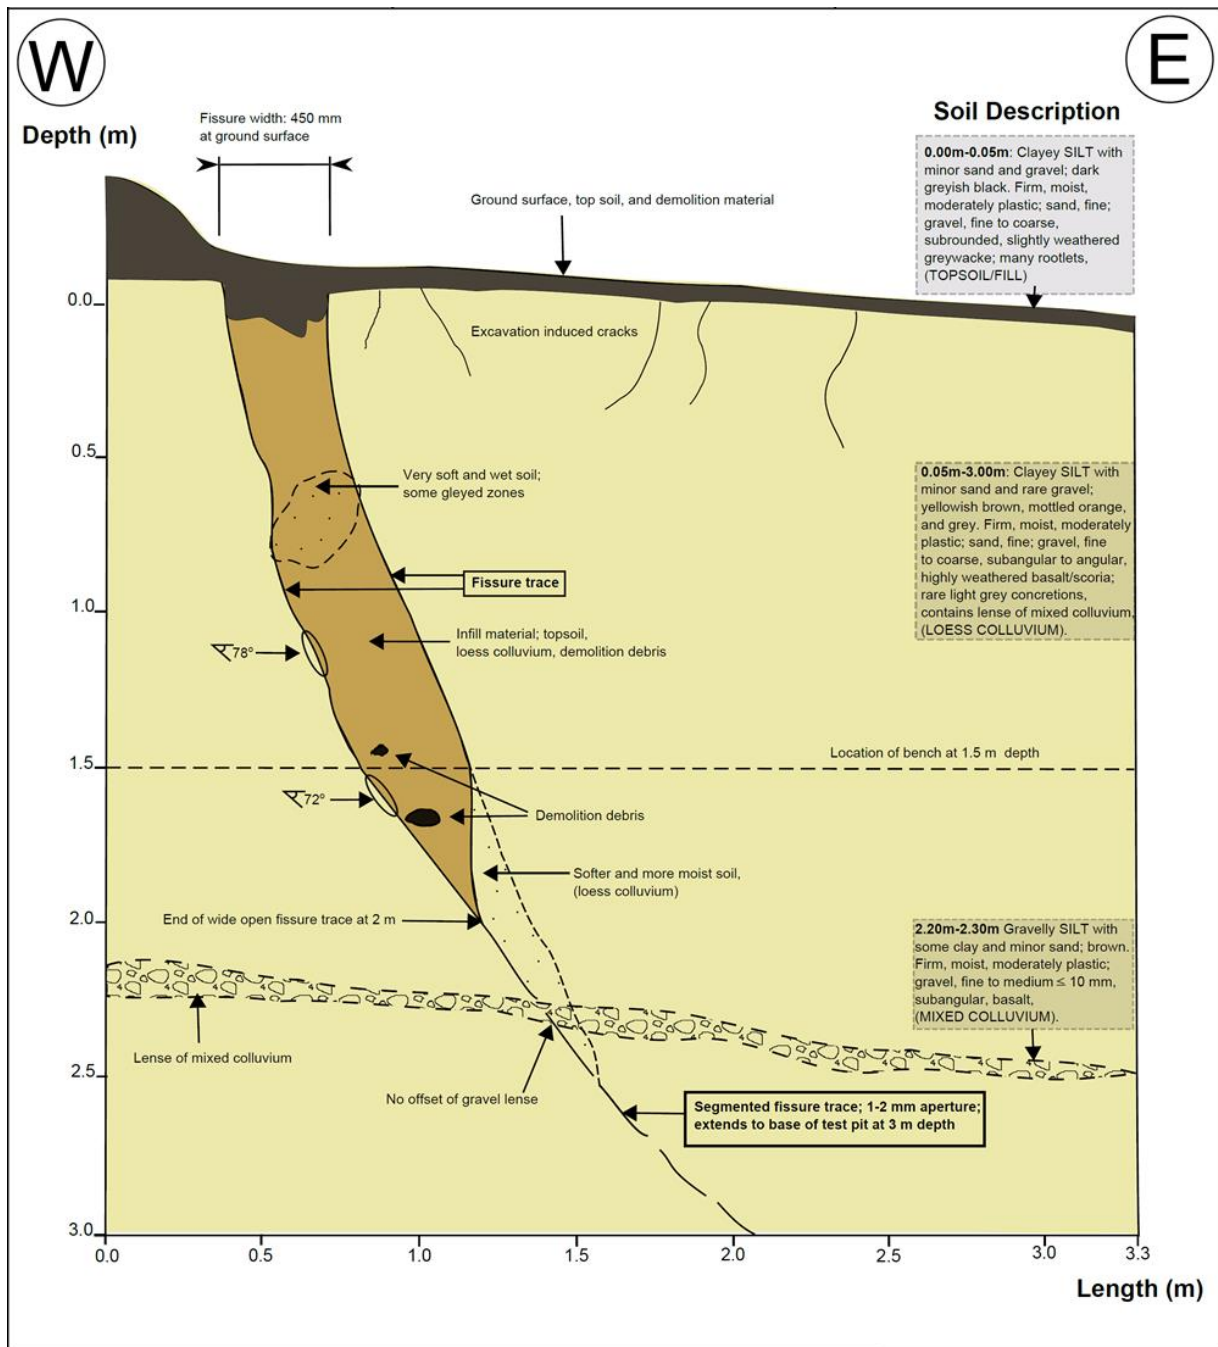
Figure 3.12 is the shallow site model for 17 Ramahana Road determined from the shallow subsurface investigation results. The soil description is based on the general engineering geological descriptions determined from the hand auger and test pit logs. The soil strength estimates in the soil description are based on the DCP and shear vane results.

The profile of the fissure trace was generalized from the logged profile of the north and south wall of the test pit. The key features of the fissure trace are displayed, which include: the flattening off of the fissure trace with depth, the loss of aperture of the fissure trace with depth to 1-2mm thickness at 2m depth, the segmentation of the fissure trace below 2m depth, and the absence of offset in the mixed-colluvium layer that intersected the fissure trace at 2.4m depth.

Figure 3.12: Shallow site model for 17 Ramahana Road.
